Facility Condition Assessment Report

Town of Amherstburg

Fire Station Three (3)

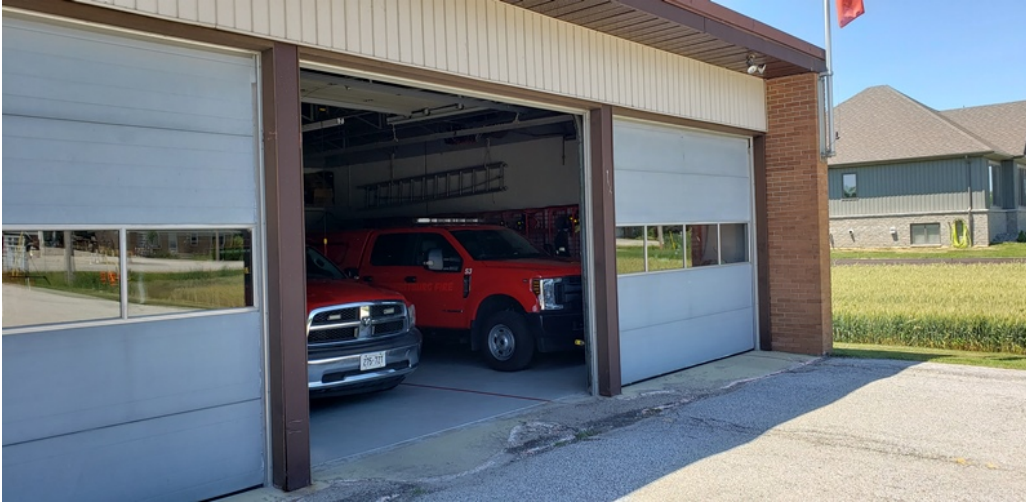
**B10 Superstructure** - With the changes in the type of trucks available, the current overhead doors are not satisfactory; these doors are too small to handle the new trucks, and it will require significant construction to accommodate these newer trucks adequately.

**Figure (1)** Asset Exterior – Overhead Doors are too small for the new Fire Trucks

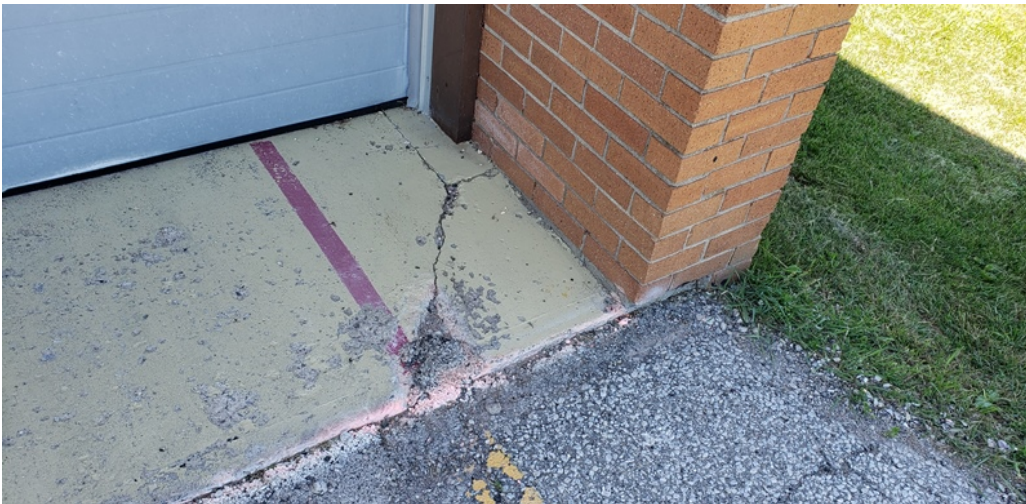
**A10 Substructure** - There are several areas of the building foundation that have been compromised either by weather or age, these areas are deteriorating and will require significant repairs soon. Due to the possible water intrusion at the foundation level, the slab base may have been weakened; only a thermal imaging scan can provide more detail.

**Figure (2)** Bay Door Access – Slab on Grade Cracks

A1032 Structural Slab on Grade	General Building Area	Structural Slab on Grade - Light Industrial, with the possible water intrusion at the foundation level it is possible that the slab based has been weaken	Reliability	Immediate action required	75	1960	61	1	2022	3286	S.F.	\$15.04				\$49,421.44	\$12,355.36	\$4,942.14	\$66,718.94	6 - Engineering Study	5
A1034 Trenches, Pits and Bases	General Building Area	Floor trench drain system installed	Reliability	Average wear for building age; not new but no issues to report	50	1960	61	1	2022	25	LF.	\$253.63				\$6,340.75	\$1,585.19	\$634.08	\$8,560.01	2 - Poor - End of the expected lifecycle. Replace within 2 - 5 Yrs.	10
A1011 Wall Foundations	General Building Area	Study to be perfomed to review the condition of the foundation and slab systems	Reliability	Allowance provided for Engineering Study	1	2021		1	2022	1	EA.	\$80,000.00				\$80,000.00	\$20,000.00	\$8,000.00	\$108,000.00	2 - Poor - End of the expected lifecycle. Replace within 2 - 5 Yrs.	10

It is recommended that a structural engineer be engaged to perform a review of the current condition of the foundation and the grade slab.

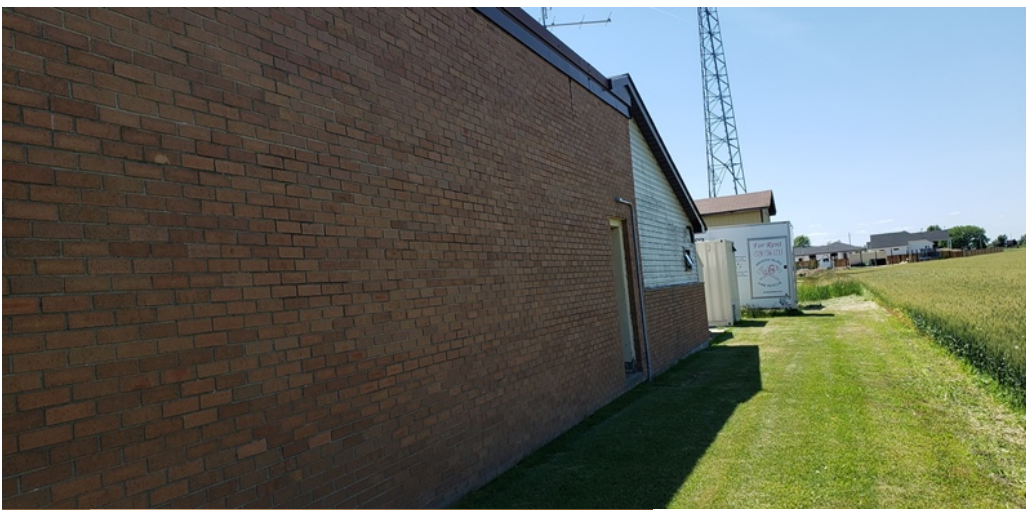
**Figure (3)** Exterior View of Masonry Brick

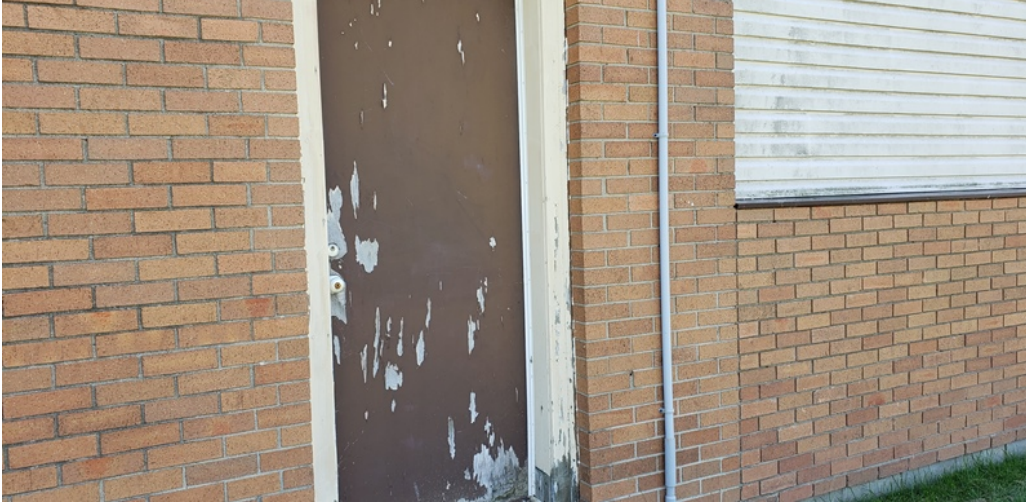
**Figure (4)** Exterior of Building & Damaged Hollow Metal Door

B2030 Exterior Doors	General Building Area	Exterior doors include 3 x 7 hollow metal panel doors set in metal frames. Doors are equipped with lever and/or pull type access and panic egress hardware. Includes painted door and painted frame. These doors are ageing	Reliability	Average wear for building age; not new but no issues to report	65	1960	61	4	2025	3	EA.	\$3,699.15				\$11,097.45	\$2,774.36	\$1,109.75	\$14,981.56	2 - Poor - End of the expected lifecycle. Replace within 2 - 5 Yrs.	10
B30 Roofing																					
B301022 Conventional - Modified Bitumen	General Building Area	The roof covering is comprised of a modified bitumen system with a cap-sheet over roof deck insulation.	Obsolescence	Reached the end of expected useful life. Useful life extended no more than 2 yrs.	35	1960	61	1	2022	1899	S.F.	\$16.32				\$30,991.68	\$7,747.92	\$3,099.17	\$41,838.77	2 - Poor - End of the expected lifecycle. Replace within 2 - 5 Yrs.	10

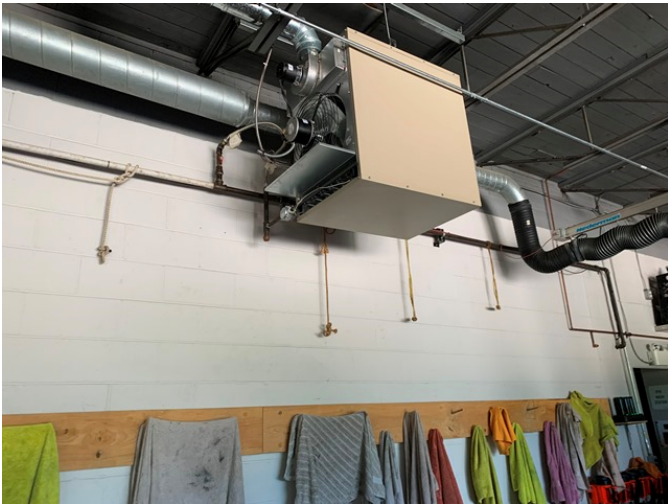
**Figure (5)** Interior View – Unit Heater

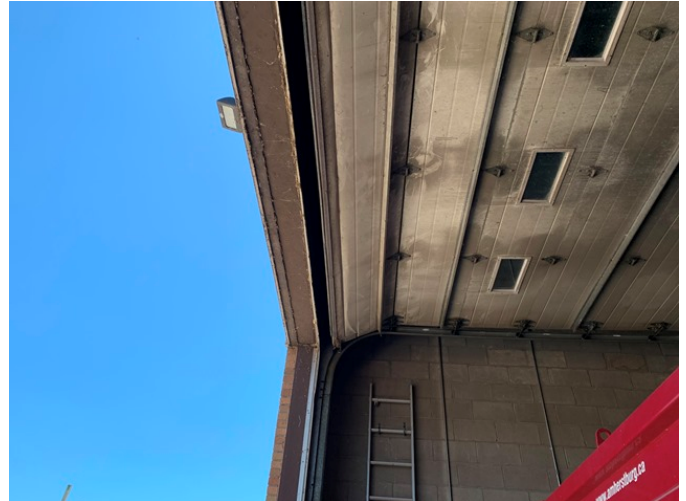
**B20 Exterior Enclosure** – Based on the observed conditions at the assessment, most external systems – Overhead doors, Wooden siding, Exterior windows, Storefront and Hollow metal doors need replacement.

**Figure (6)** Overhead Doors

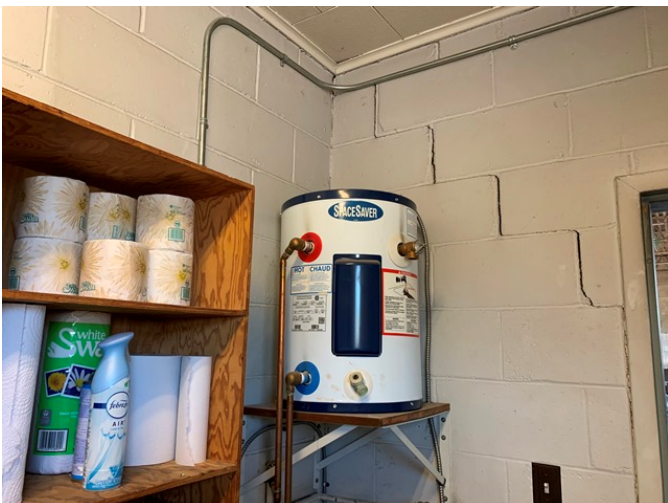
**Figure (7)** Interior View - Observed Step Cracking

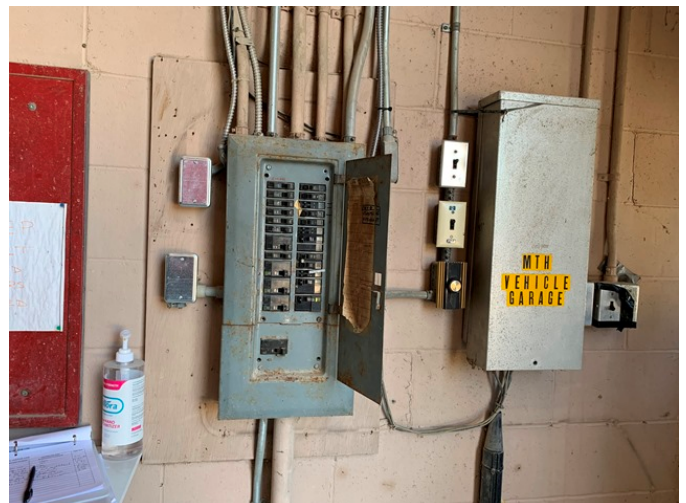
**Figure (8)** Interior View – Electrical Panel is aged and has reached the end of its useful life
