December 9, 2024

Project No. 25029

**RE: Amherstburg Town Centre  
South Elevation Facade**

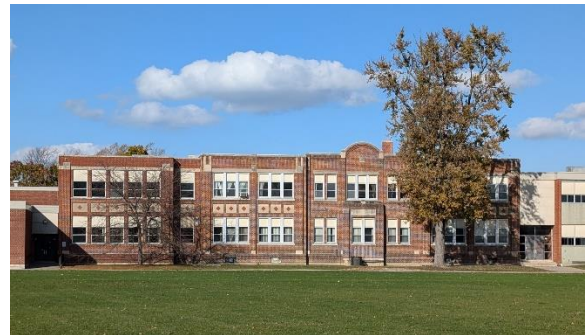
Fig. 4: Historic façade and 1950's addition, today.

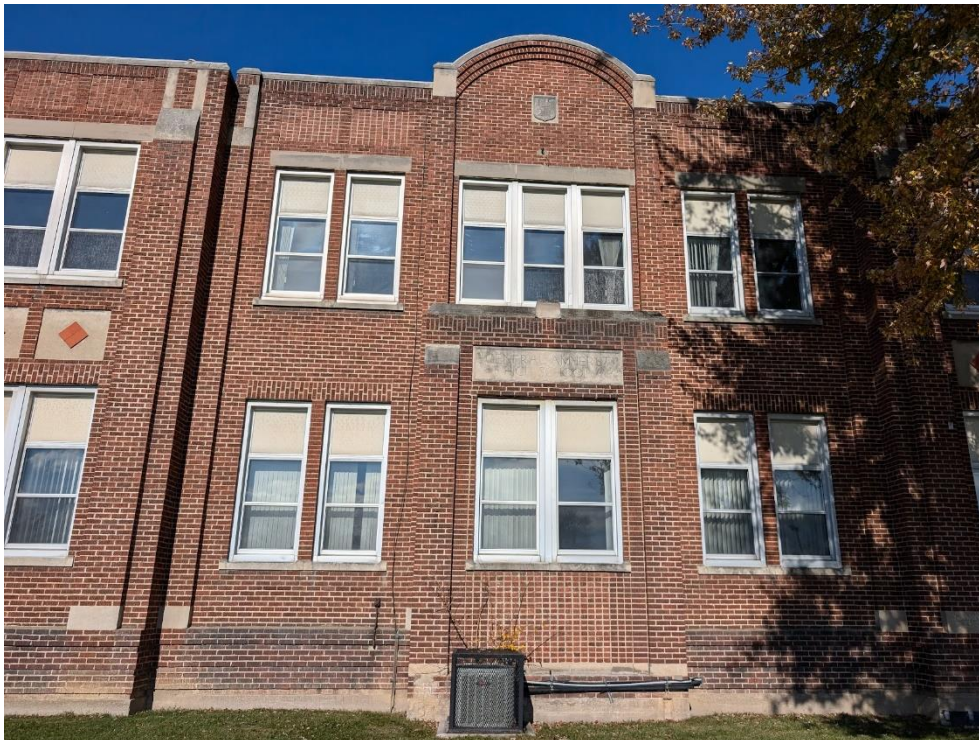
Fig 5: Closer view of façade, showing brick bond patterns, stone details, piers.

The wall construction consists of a single exterior wythe of red brick which has a rugg texture (vertically combed) that is relatively coarse. The brick is laid primarily in a running bond pattern of stretchers, with no regularly spaced header courses in the field. There are soldier courses above windows and below the coping stones, several rowlock courses to form a circular arched parapet above the former central doorway, and panels of stack-bond headers (likely false headers) between the uppermost windows and the roof. The brick bond patterns can be seen in Figure 5, above.

Limestone details are present as sills below windows, at the tops and bottoms of piers, and as coping stones along the top of parapet. This appears to be Indiana Limestone which remains an actively quarried and available material. There are also rectangular panels along the second-floor level of the east and west wings of the façade. These appear to consist of a cementitious parging with a terra cotta tile rhombus set in their center. The backup for these panels is not known and would likely be brick or terra cotta tile. See Figure 5, showing the general arrangement of these details.

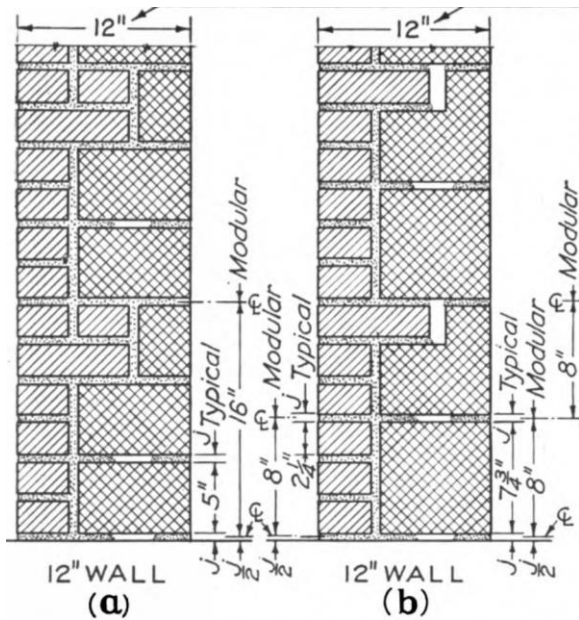
As previously noted, there is a distinct absence of header bricks. While headers do appear to be present at the sides of piers to key them into the regular plane of the wall, and aside from the decorative panels of stack bond headers (which I suspect are false headers), no headers exist in the regular field of the wall. Figure 7 below, extracted from the Principles of Tile Engineering Handbook of Design, published in 1946, shows a typical construction of a composite brick-tile wall, with headers to key the wythes. The alternative means of securing the exterior brick to the tile backup would be to incorporate masonry ties, similar to common veneer applications constructed today.

While no systematic brick bulging or displacement was evident during the review of the General Amherst High School's facade, veneer construction at the time of its construction was often not to the standards of today, and the possibility remains that anchorage is insufficient in spacing. It is also very likely that any anchorage that is present may consist of plain steel or thin sections that are prone to corrosion. Another possibility, though we have not seen it in composite brick-tile construction such as this, is the use of concealed diagonal headers (also called clipped headers), which are often ineffective and prone to separation.

Fig. 7: Typical historic brick-tile wall detail.

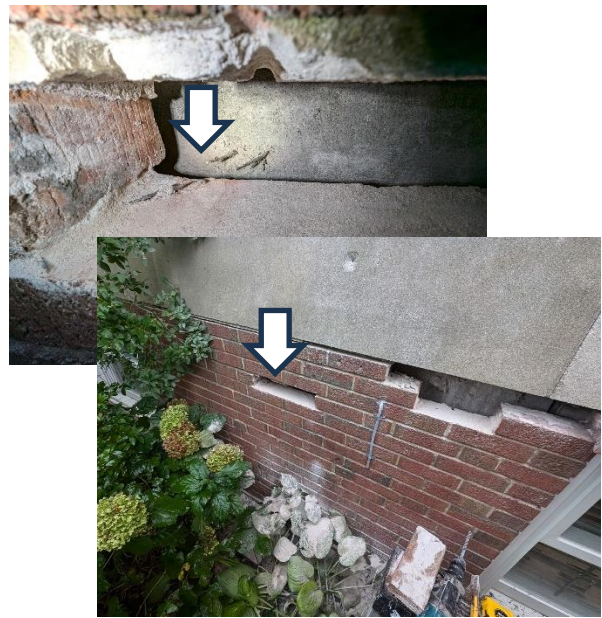
We recently reviewed the Strathroy Town Hall building, which was built ca. 1928 and with a similar exterior brick, Indiana limestone details, and concrete foundation walls to this building. The brick along its concrete foundation wall is a single-wythe veneer and was outwardly displaced in many areas. Exploratory openings revealed that within a 7'x4' panel there was just a single plain steel wire loop cast into the concrete and set in the bed joint of the brick, possibly having been intended as a veneer tie. However, as illustrated in Figure 8 below, indicating the location of the tie and with a closeup of the tie itself, this sole tie was not resistant to corrosion, nor was it sufficient to adequately restrain the brick in the first place.

Fig. 8: Brick veneer and tie at Strathroy Town Hall.

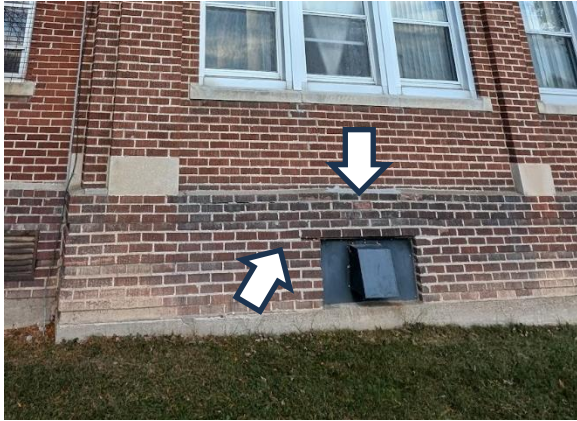
Several brick courses at the base of the wall project beyond the wall above, to form a water table or plinth course along the base of wall. Unfortunately, this projection consists only of brick masonry and parging and does not effectively shed water, providing a skyward facing surface upon which it can collect and be absorbed into the wall below. The deterioration here is relatively limited, overall, however, there are signs of corrosion of steel lintels above openings and resulting cracking (see Fig. 9), and there are eroded joints and spalled bricks due to moisture-related deterioration (see Fig. 10). A strip of metal flashing set into a reglet and with a drip edge beyond the wall below would have better protected this area.

Fig. 9: Cracks, repairs to water table at base of wall

- Cut façade at corner return walls and consolidate cut ends of masonry. \*
- Infill joist pockets at interior side of façade. \*
- Locally repoint along the parapet. \*
- Reset displaced stone units. \*
- Repoint, locally rebuild, and locally replace brick along water table at base of wall. \*
- Local repointing throughout. \*
- Repoint all coping stone joints.
- Add metal flashing to protect masonry projection above main entrance projection.
- Add metal flashing to protect masonry projection at water table.

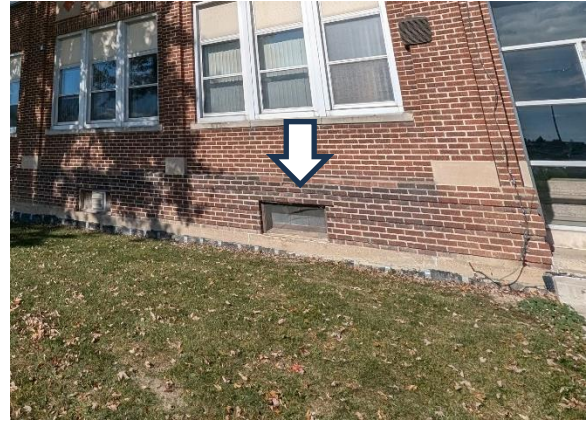
Fig. 10: Spalling brick at water table

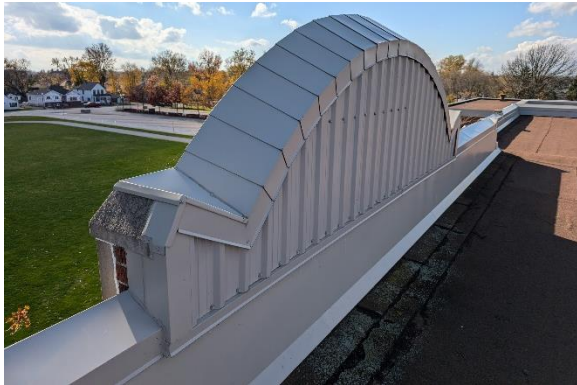
For the most part, the masonry at the upper areas of the wall is in relatively good condition, and fair-to-good condition along the parapet. As expected, there are some areas of eroded or debonded mortar joints. The previously mentioned placement of metal flashing to discretely protect most of the skyward facing masonry has performed well and is likely a key factor in the good condition of the masonry (see Figure 11).

Fig. 11: Cap flashing atop parapet coping stones.

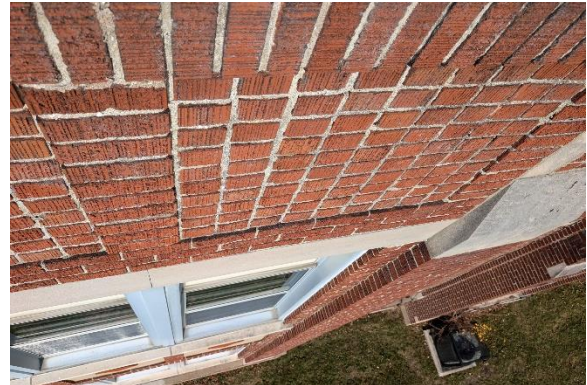
Fig. 12: Mortar joints at parapet.

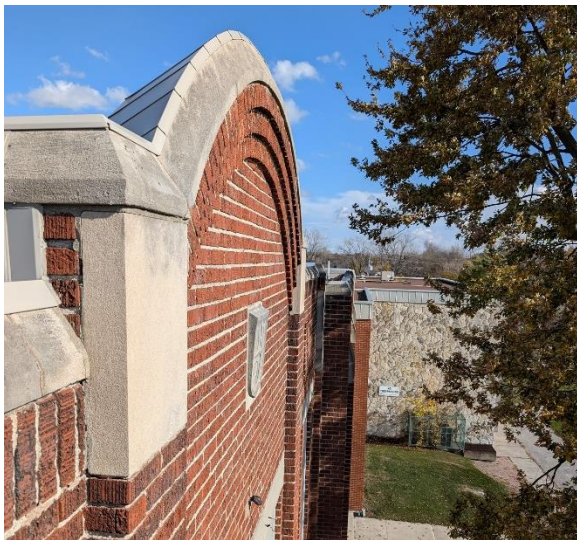
Fig. 13: Arched central bay of parapet.

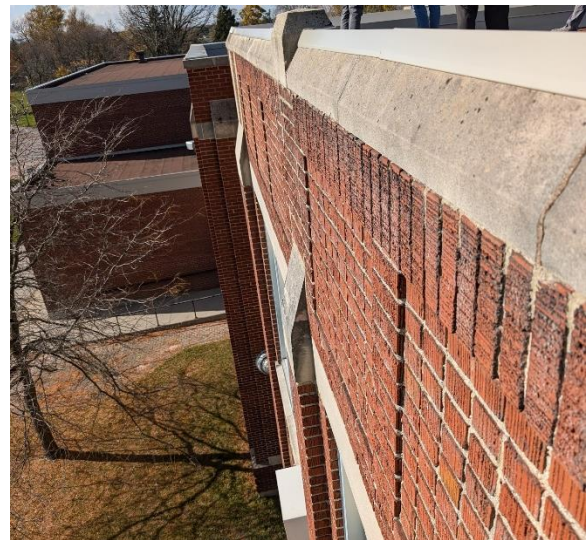
Fig. 14: Typical condition along parapet.

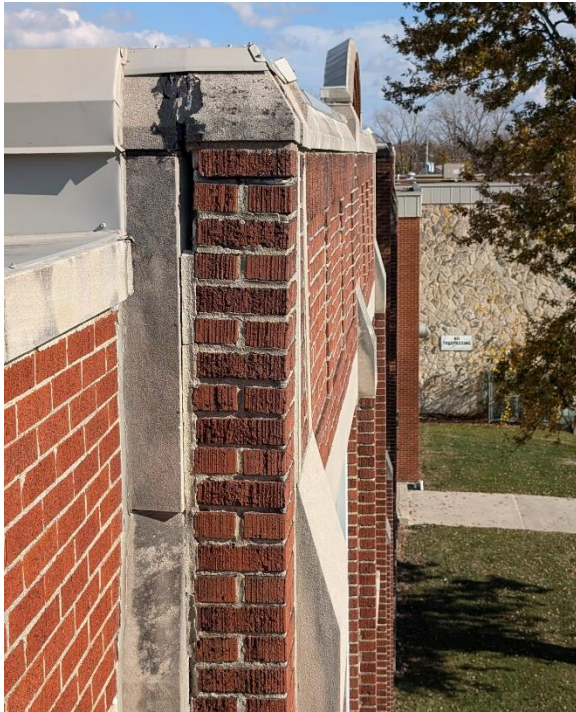
Several of the stone units at the upper levels of the building were noted to be displaced. See Figures 15 and 16 for examples. The stone at Figure 15 abuts the 1950's addition, and may be impacted by differential movement between the two structures. The movement in the example at Figure 16, a relatively slender stone, is likely due to the failure of its anchorage or a lack of anchorage when it was constructed.

Fig. 15: Displaced stone at SW corner of facade.

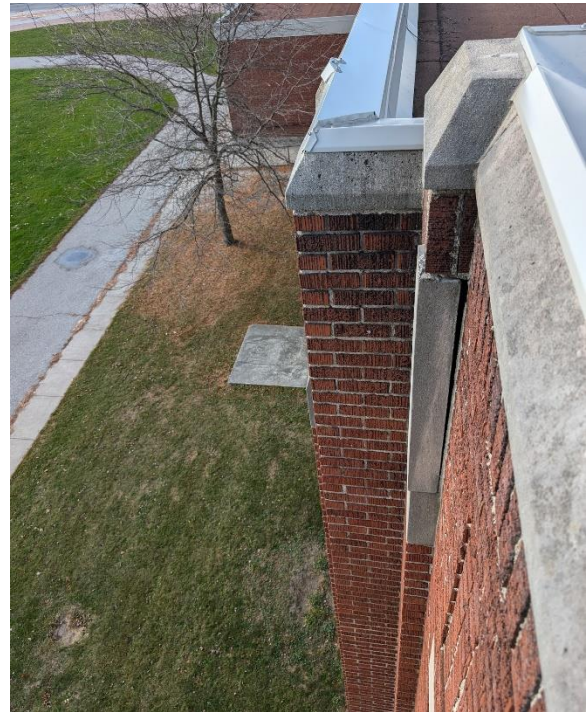
Fig. 16: Displaced stone at return at west wing.

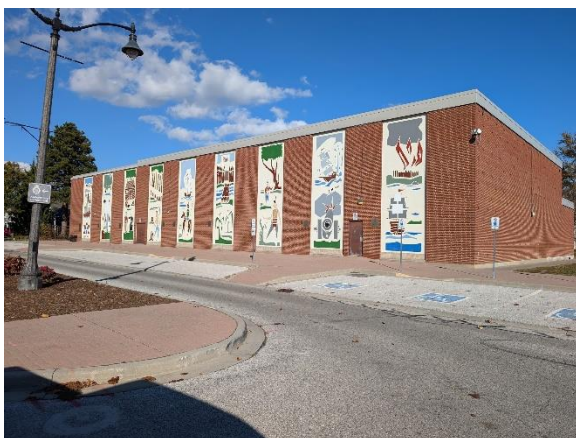
The murals on the West Elevation of the gymnasium building were also reviewed (see Figure 17). It is understood that the gymnasium structure upon which the six southern panels are located will remain in-situ as part of the new development, but that the three remaining panels to the north are on a structure that will be demolished and that options to preserve these murals are sought.

Fig. 17: West Elevation mural panels.

The murals appear to be painted onto cementitious parging applied to concrete block construction, and they are in good condition. They were restored in 2012 according to a plaque to the north of them (see Fig. 18). The murals are recessed from the adjacent brick and do not extend all the way to grade, with

approximately 18" of wall tile having been installed below them. The murals are painted with relatively few colours and in fairly simplistic shapes, and the profile of the coloured areas appears to be noticeably raised from the adjacent field.

One approach is to detach and relocate the murals, and apply them to whatever new structure is constructed in place of the current building. This would require steel framing to sandwich the block wall panels, steel needle beams placed perpendicularly under the panel, disconnection from the adjoining walls, and lifting of the panels by crane to and from a temporary storage location that would presumably be on the site.

Another option may be to recreate the murals by repainting them onto a surface of the new building. This could even be in some other form if that building's wall is not suitable for painting, such as etchings on panels of a glass façade, or free-standing panels or if there is no building in that place.

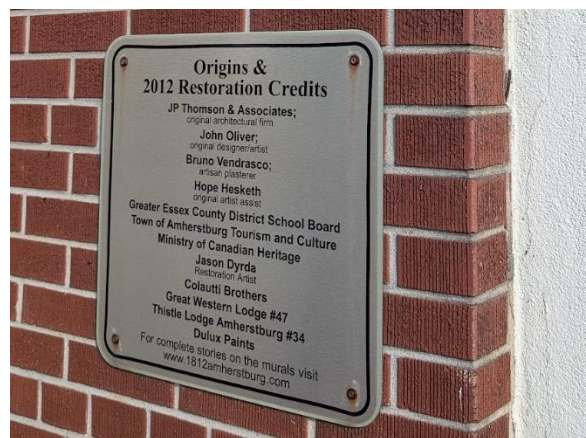
Fig. 18: Plaque regarding 2012 mural restoration.

Any masonry painting should be done with appropriate paints, ideally sol silicate paint, and should be done by artists with appropriate experience. The plaque at Figure 18 includes the name of the artist involved in the 2012 mural restoration who would no doubt be very well-suited to such work, but there are other artists with similar experience. For example, we recently completed a project at the Elgin and Winter Garden Theatre in Toronto that included an artist to re-paint a historic sign on the side of the theatre and which went very well.

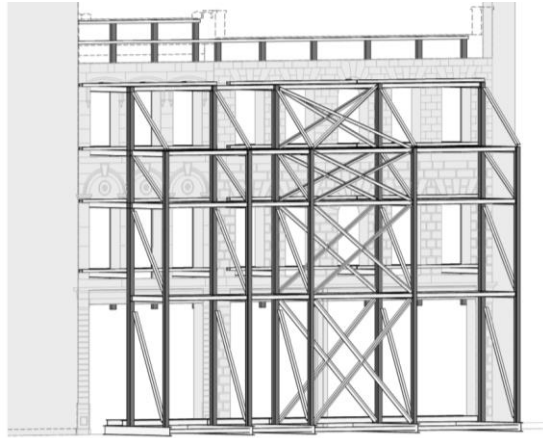
Fig. 19: Example 3D model of façade retention frame.

There are two common ways of retaining a façade in-situ, which are to either construct a temporary frame to laterally brace the wall while the existing building is separated from it and demolished, or to leave and brace a bay of the existing structure along the façade to serve as bracing. The latter has the benefit of minimizing the extent of the temporary construction needed to brace the wall, at the expense of a more complicated environment in which to construct the new building and is generally more advantageous in taller buildings. Given the relative size and height of the façade, the more typical approach of constructing a structural steel braced frame on the exterior side of the façade is considered for this facade (see Figure 19 for an example).

The braced frame would include horizontal steel members placed on the interior and exterior faces of the façade, primarily along the tops and bottoms of window openings, to sandwich the wall. The frame could be placed on footings, with ballast (large concrete blocks) to resist overturning

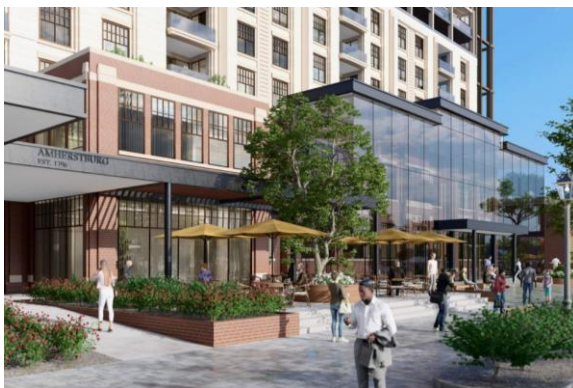
Fig. 20: Potential glass enclosure along facade.

It is understood that a glass enclosure proud of the façade is being contemplated as part of either option. Glass interfacing with heritage masonry does tend to showcase the heritage fabric, and its lightness and transparency can give a certain deference to solid masonry as the primary feature of a space. Having a former exterior wall in a new interior space can also add a lot of interest and appeal. An example that the undersigned worked on extensively, and which won a CAHP award of excellence for adaptive re-use is the Sir John A. MacDonald building at 144 Wellington St. in Ottawa, ON (see Figure 21).

Based on the information at hand, the decision to build an enclosure should be made primarily at an architectural level. While the enclosure would provide full protection from the elements, and therefore mitigate any further deterioration, the façade has performed quite well to date, and this level of protection is not required to assure additional lifespan in its new use. Protection would eliminate the need to analyze brick properties, envelope performance, and the installation of new flashings.
