TOWN OF AMHERSTBURG

AMHERSTBURG FIRE STATIONS

COST COMPARISON REPORT

March 2023

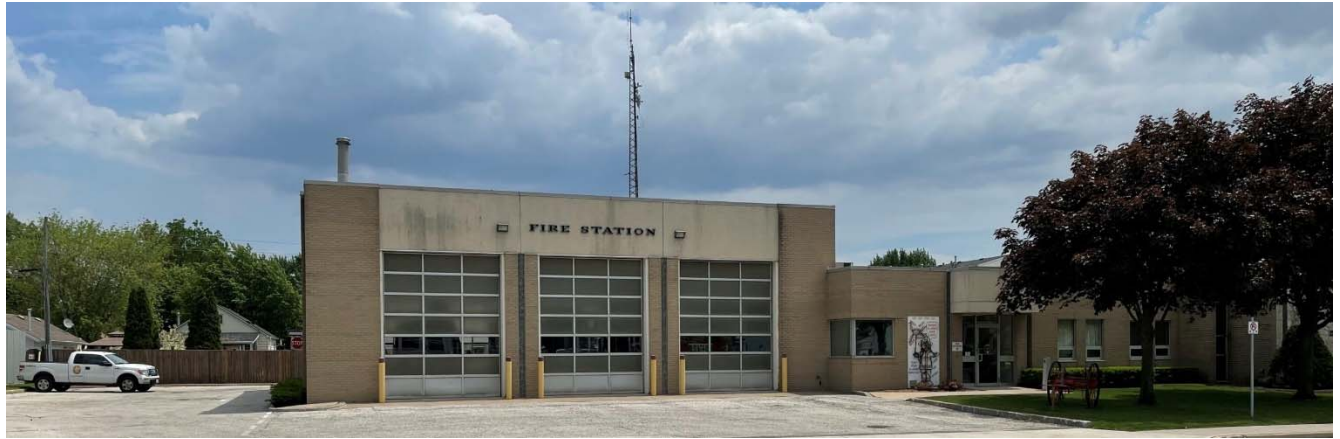
Figure 1: Fire Station 1 - Front Elevation

Fire Station 1 is located at 271 Sandwich Street South in the Town of Amherstburg. The facility is connected to the Town Hall building, which was built in 1950 and the fire station was added in 1993. The building is a single storey structure with a partial basement floor. The Gross Floor Area (GFA) is 19,746SF composed of 13,653SF of ground floor and 6,093SF of basement floor. The fire station is about 7,140SF at the ground floor level.

According to the Building Assessment Report prepared by JS Held, the building is valued at approximately \$3,259,310.00 and requires repairs in the order of \$4,897,223.00 in 2022 dollars. See Appendix A1.

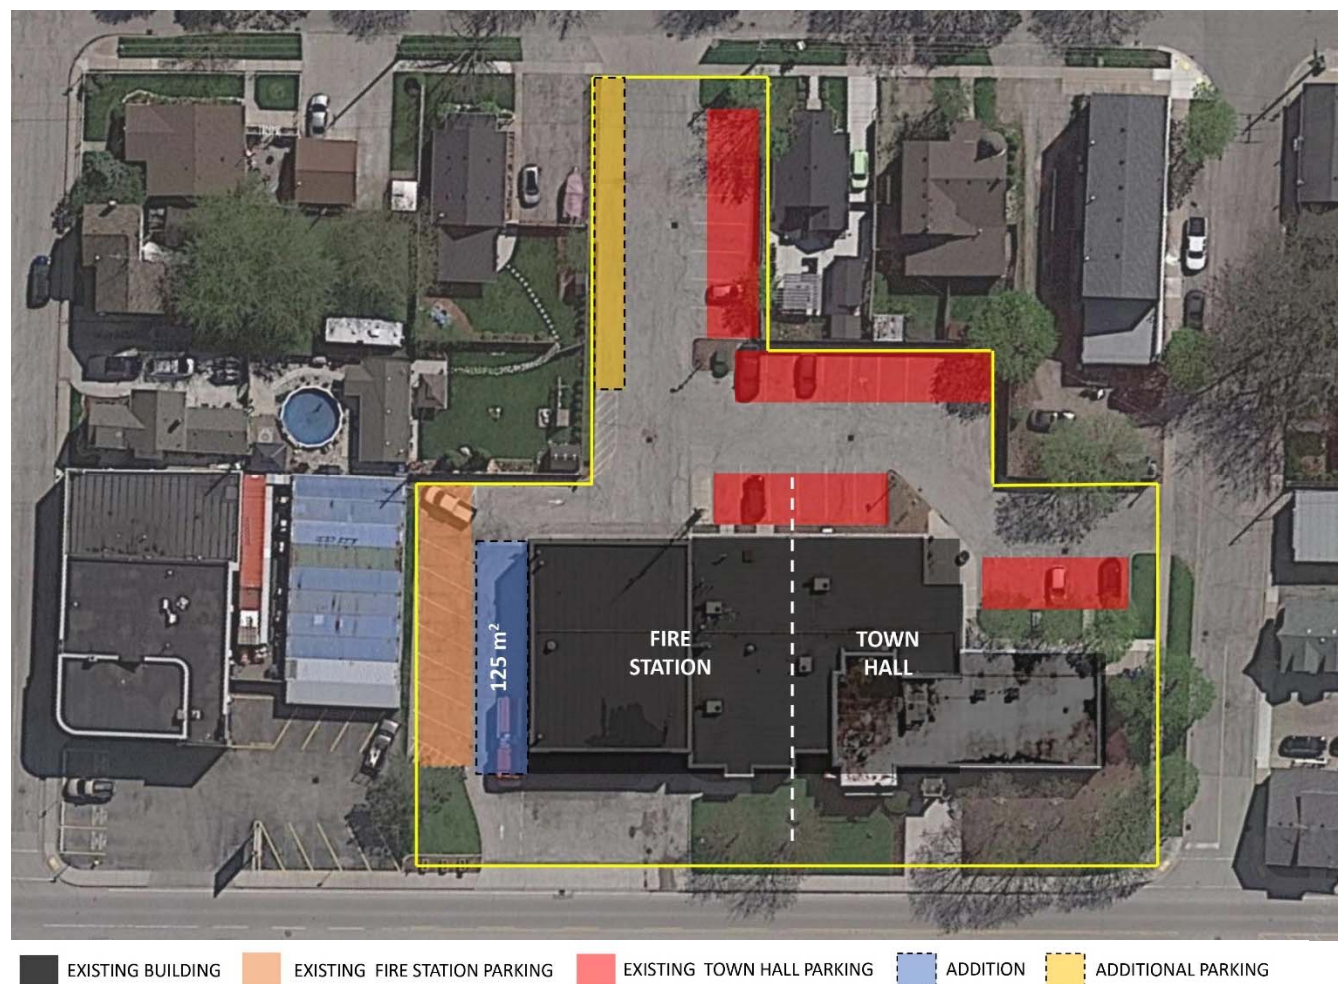
Figure 4: Fire Station 1 - Site Plan Expansion Potential

The site diagram shows limited to no ability to expand to the building. A maximum area of 125m² or 1332SF may be available, but at the expense of maneuverability and parking which is already less than needed.

As a result of the limited site, an addition to the town hall building is not physically possible. This restriction removes the possibility of adapting fire station 1 for future use from consideration as an actual viable option. Nevertheless, the costing exercise was completed in an attempt to put a dollar value to the improvements needed for sake of fair comparison.

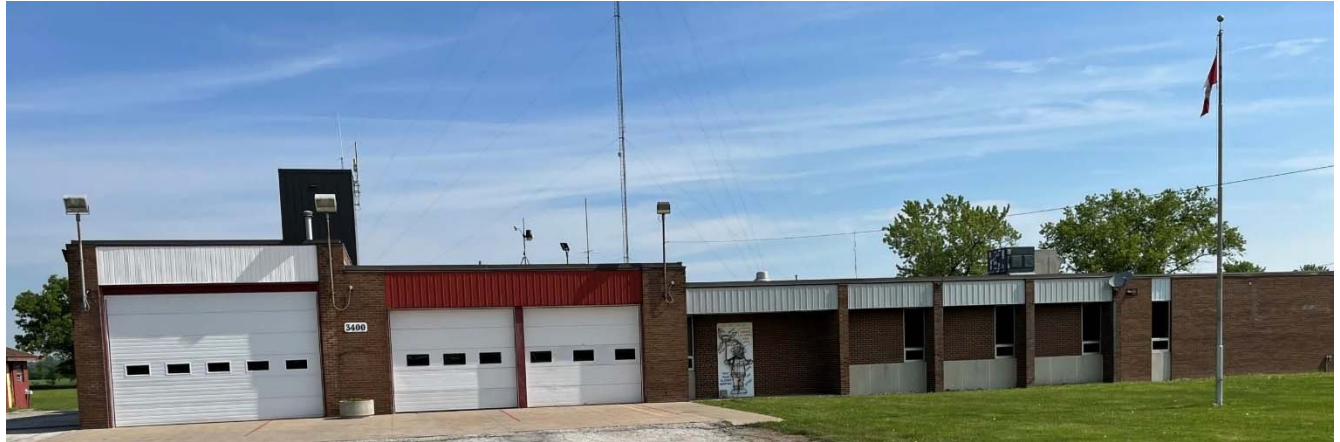
Figure 5: Fire Station 2 - Front Elevation

Fire Station 2 is located at 3400 County Road 10 in the town of Amherstburg. It is a small single storey building of masonry and wood construction with an area of 7,714SF approximately. The building was constructed in 1962, with an addition made in 1965 and multiple interior renovations seem to have been completed with the last being in 1974. The building is a three single bay fire facility with two of the bays shorter than the third. The building includes a good size non-fire bay area of about two thirds of the overall area.

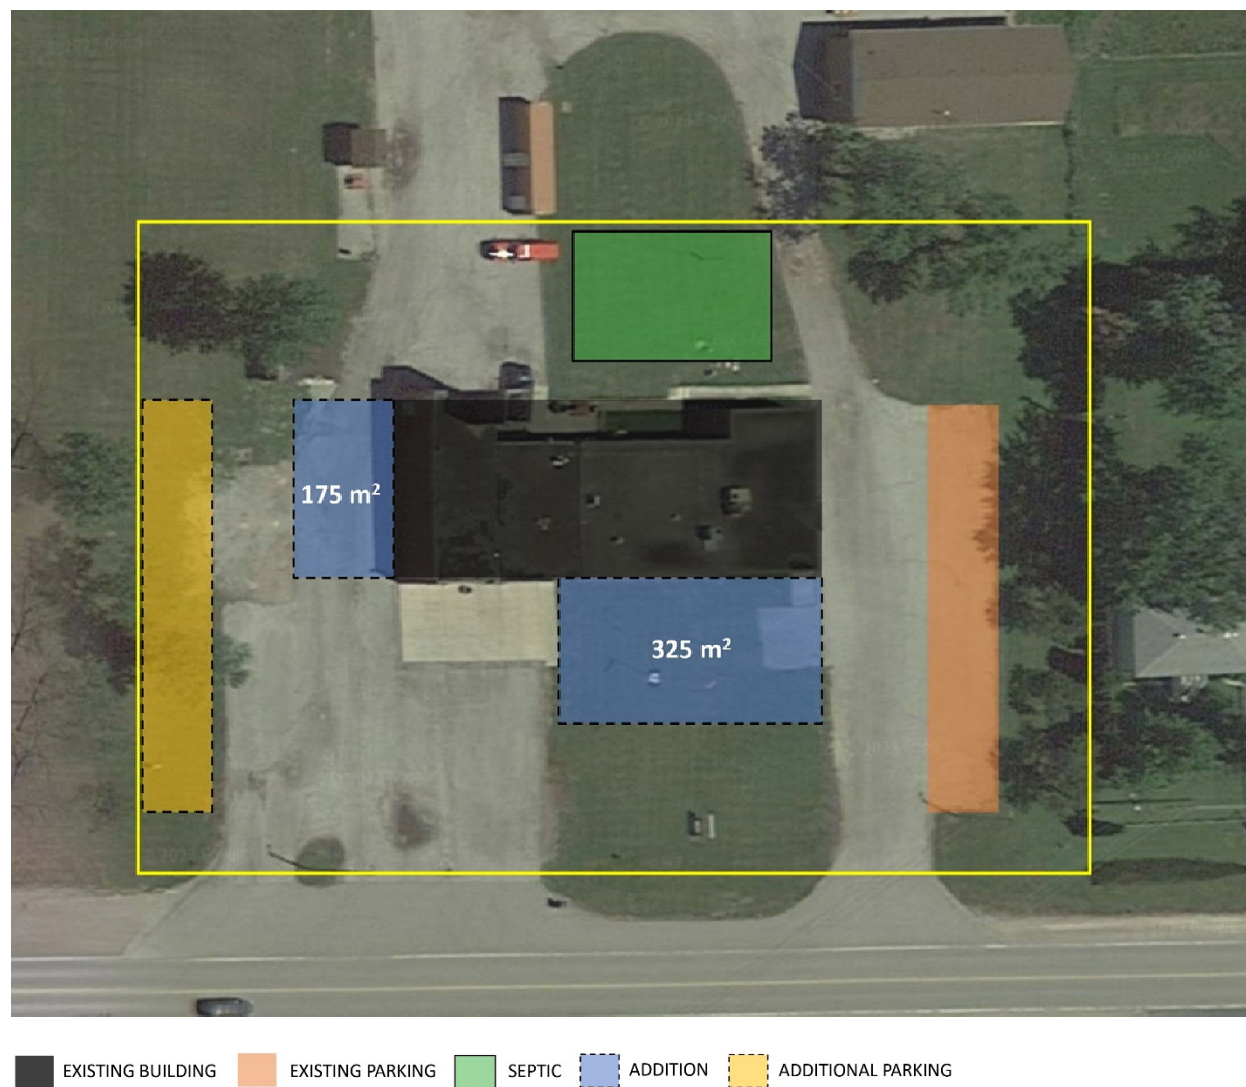
Figure 8: Fire Station 2 - Site Plan Expansion Potential

The site diagram shows possibilities to expand to the building at the front and the side to within the area needed for an expansion. With careful planning additional parking can be achieved.

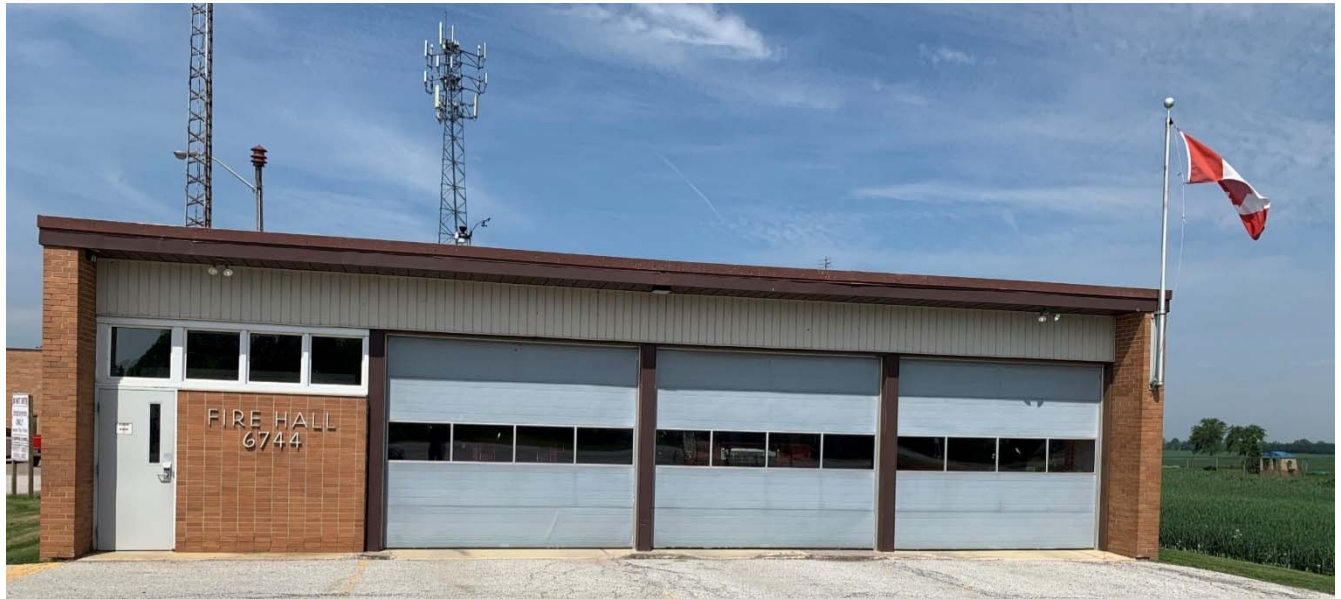
Figure 9: Fire Station 3 - Front Elevation

Fire Station 3 is located at 6744 Concession Road 6 South in the town of Amherstburg. It is a single-storey building constructed in 1960 of approximately 3286 SF. It is a three single stacked fire facility with a small office area in the rear.
