# **Flood/Rainfall Event: August 23-25, 2023**

**Update for ERCA Board of Directors Meeting – October 12, 2023**

Essex Region Conservation Authority

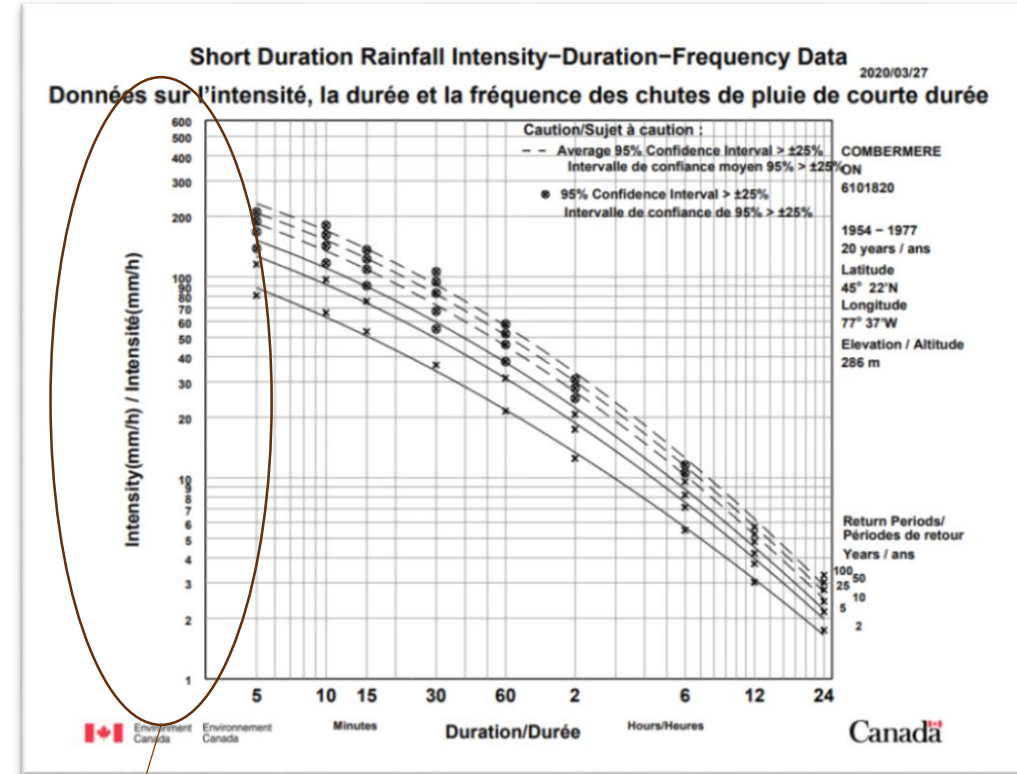
# IDF Curves – What are they?

Rainfall data is collected by ECCC, reviewed, and fit to a specific statistical distribution, with intensity and corresponding duration plotted for each statistical return period.

Intensity x Duration = Depth  
Example: 4.5 mm/hr x 24 hours = 108 mm
