SUBJECT: HERITAGE EVALUATION - 247 Brock Street, Amherstburg

- 247 Brock Street, Annerstburg
- The Lofts at St. Anthony

ATTACHMENT 1

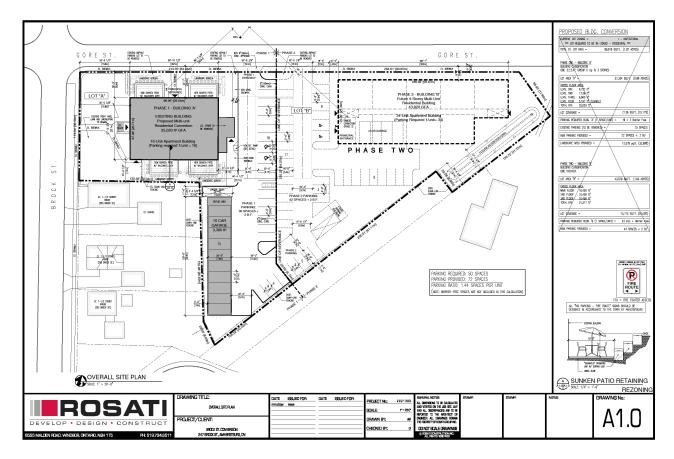
SITE PAIN: ACHMENT 1

EXTERIOR FEATURES IN BYLAW		PROPOSED MODIFICATIONS, IF ANY
1.	Original location and placement on Brock Street, adjacent to St. John the Baptist Roman Catholic Church. (SITE PLAN, PICTURE 1)	 No change to location, building to remain in existing location – refer to attached site plan below; Refer to attached pictures showing viewscape with church and The Lofts; Landscaping to be provided that will enhance heritage characteristics of the icon limestone façade.

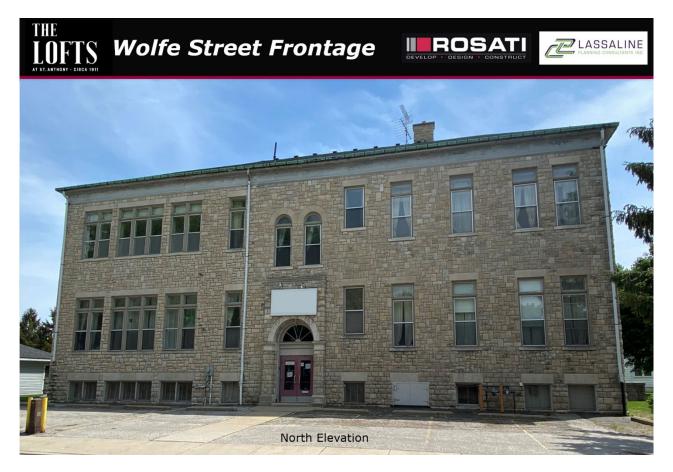
PictuAeT2 ACH4W115NeTevation:

2.	Rectangular, two-storey form on a raised basement; (PICTURES 2,3)	 No additional storeys - will remain at two storey height; No major additions to change the rectangular shape; Exterior addition of an elevator to provide for accessibility compliance and unit functionality; materials to be used include smooth faced architectural stone, vertical panel metal siding, and charcoal grey tinted glazing – complimentary to heritage features.

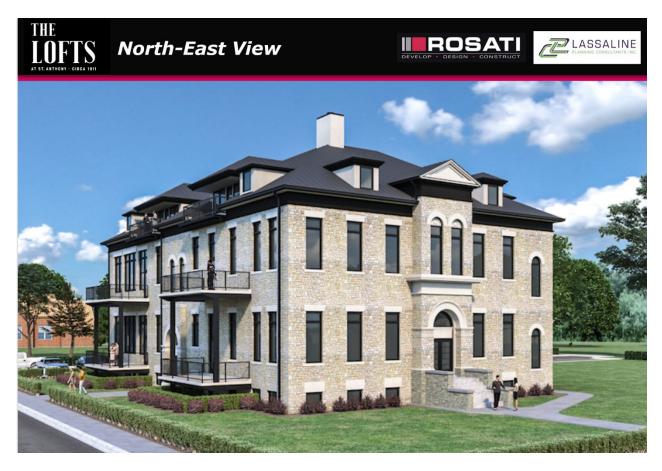
PictuAeT4AOHME-NEtast View:

3.	Hipped primary roof; gabled (pedimented) frontispiece; metal roofline cornices; secondary metal cornices atop doorways; exterior stone chimney; (PICTURES 4, 5, 6, 7, 8)	 New black metal shingled roof to match the roof on St. John's Church; Roof to be amended with dormers to accommodate lofts – roofline will be continuous; Gabled (pedimented) frontispeace; secondary metal cornices atop doorways; exterior stone chimney to remain and will have minor cleaning and repairs for the purposes of restoration and preservation; Metal roofline cornices – deteriorated condition - to be replaces with black metal roofline cornice to compliment the roof and maintain historical roofline.

4.	Masonry construction and limestone facades with sandstone detailing; the limestone main exterior stairs; (PICTURES 4, 5, 6, 7, 8)	 Minor cleaning and repairs of all façade's, sandstone detailing and main exterior stairs for the purposes of restoration and preservation; Iconic to Amherstburg limestone facades, sandstone detailing, and limestone main exterior stairs to remain;

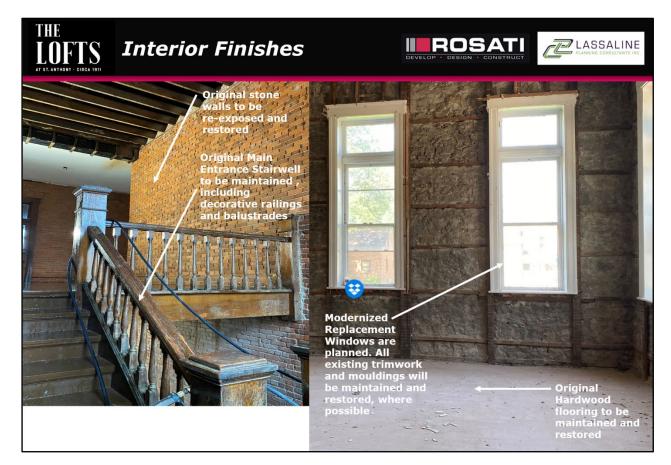
Picture 9 – Entrance:

INTERIOR FEATURES IN BYLAW		PROPOSED MODICATIONS, IF ANY
1.	Entrance staircases with wood balustrades;	 Minor cleaning and repairs for purposes of preserving and conserving the original grand main entrance stairwell;
	(PICTURE 9)	 Minor cleaning and repairs for purposes of preserving and conserving the original decorative railings and balustrades of the grand main entrance and staircase;
		 Secondary entrance on east side of building to be closed and interior space incorporated into the residential unit. Interior stairwell to be removed. Exterior entrance, and stairs to be maintained.
2.	Interior spatial configuration;	 Corridors to be maintained supporting the continuation of the interior spatial configuration.

INTERIOR FEATURES IN BYLAW	PROPOSED MODICATIONS, IF ANY
 Wood finishes comprising door and window casings, baseboards, and doors throughout (PICTURES 9,10) 	 Original stone walls to be re-exposed with minor cleaning and repairs for the purposes of restoration; Original masonry arches over doorways and doorway mouldings to undergo minor cleaning for the purposes of preserving and conserving the significant interior attributes; Original hardwood floor to be cleaned, minor repairs for the purposes of restoring and conserving; New black vinyl windows with combination of double-hung (1 over 1 sashes) and additional header fixed units to replicate original windows; All window glass to be clear glass (no tint) and energy efficient; New double hung doors with replicated fan shaped glass transom with view to improving entrance, creating welcoming entrance, and creating safe access; All existing trimwork is to undergo minor cleaning and repair and restored where possible for re-establishing in the residential units.
