**HERITAGE EVALUATION
PRESENTATION**
247 BROCK STREET, AMHERSTBURG

THE LOFTS

AT ST. ANTHONY • CIRCA 1911

Building Owners:
Terry Jones Realty Inc.

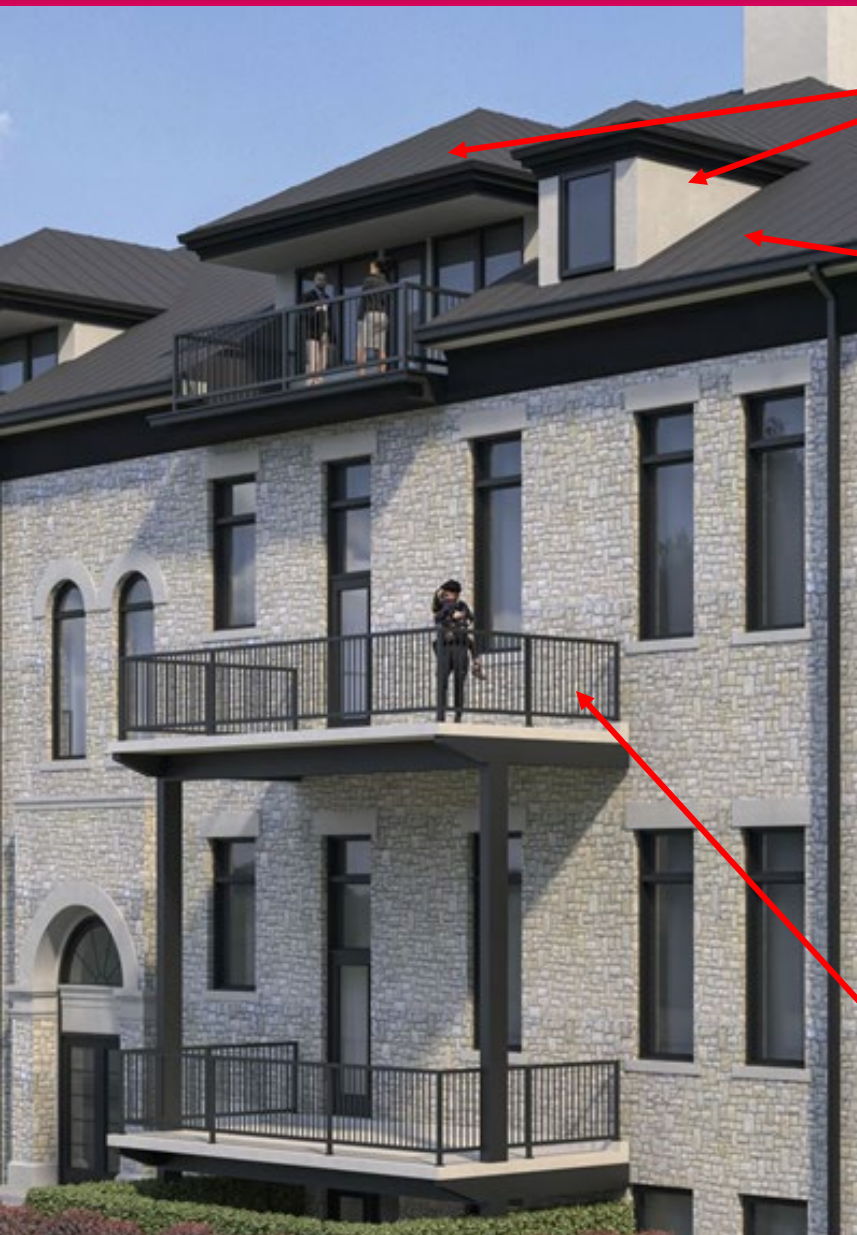
Level 4 – Dormers & Balconies

**Architectural Metal
Shingle Roofing**
(see next sheet)

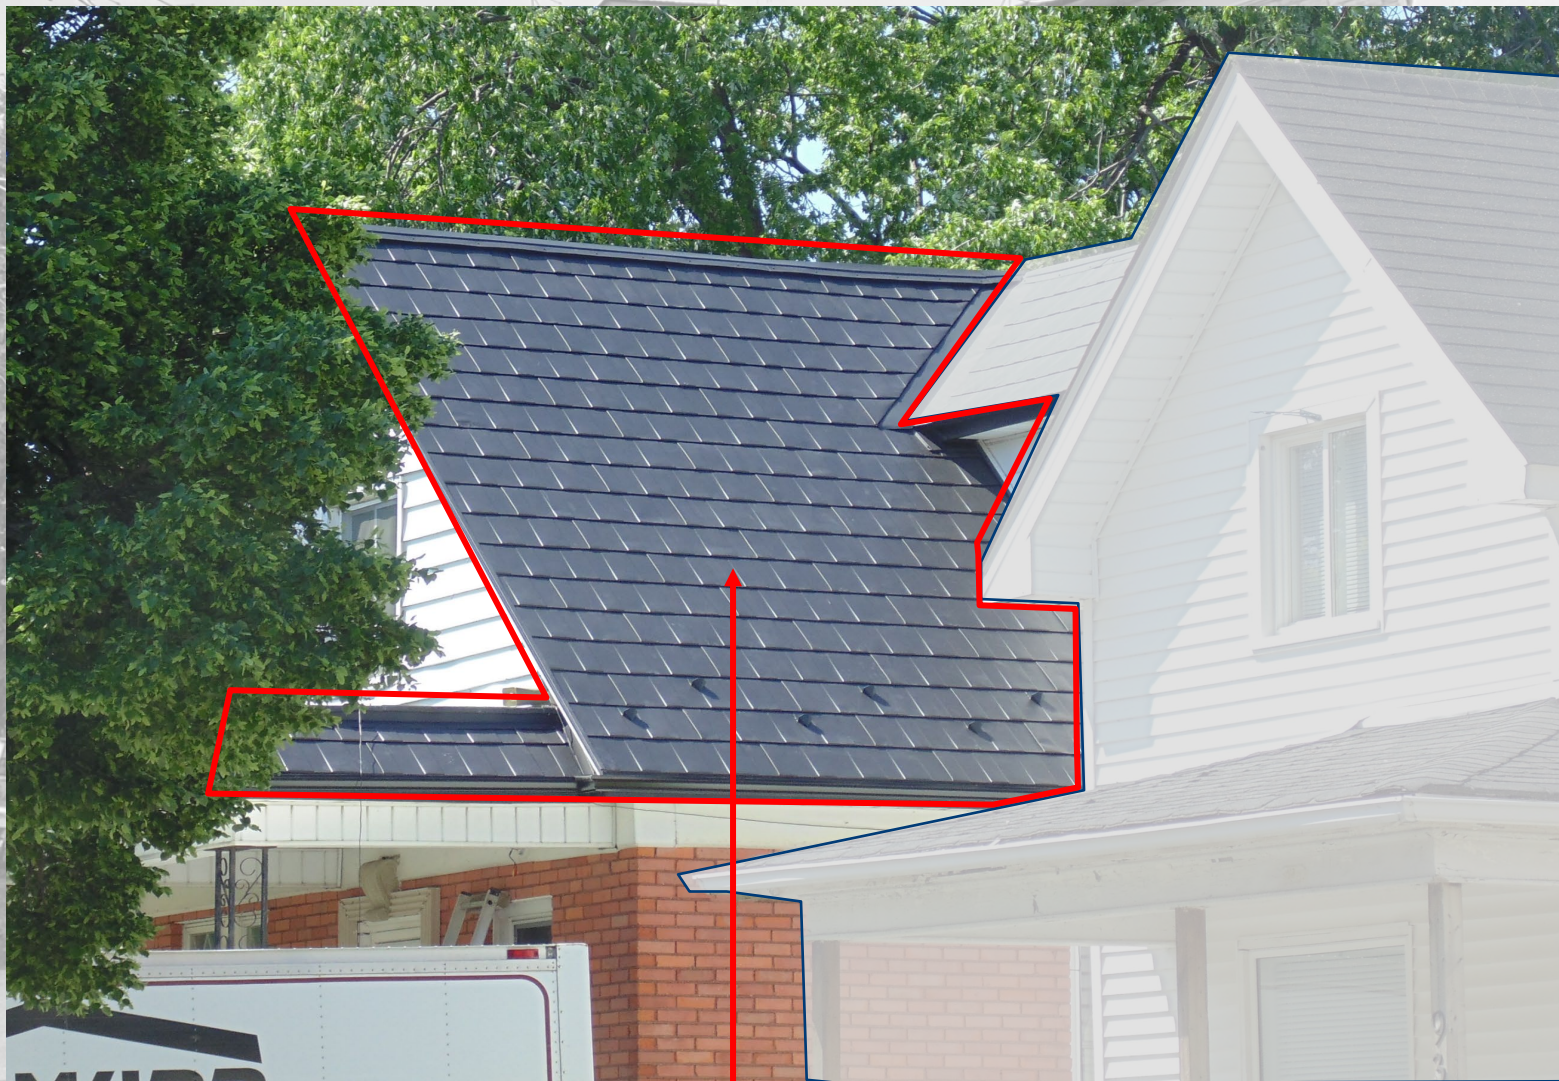
1 - Balcony Railings
Black Powder Coated, Wrought Iron Railings

2 – Architectural Metal Shingles

4 – Charcoal Grey tinted Glazing

2 – Architectural Metal Roofing Shingles

3 – Smooth Face Architectural Stone

1 - Balcony Railings

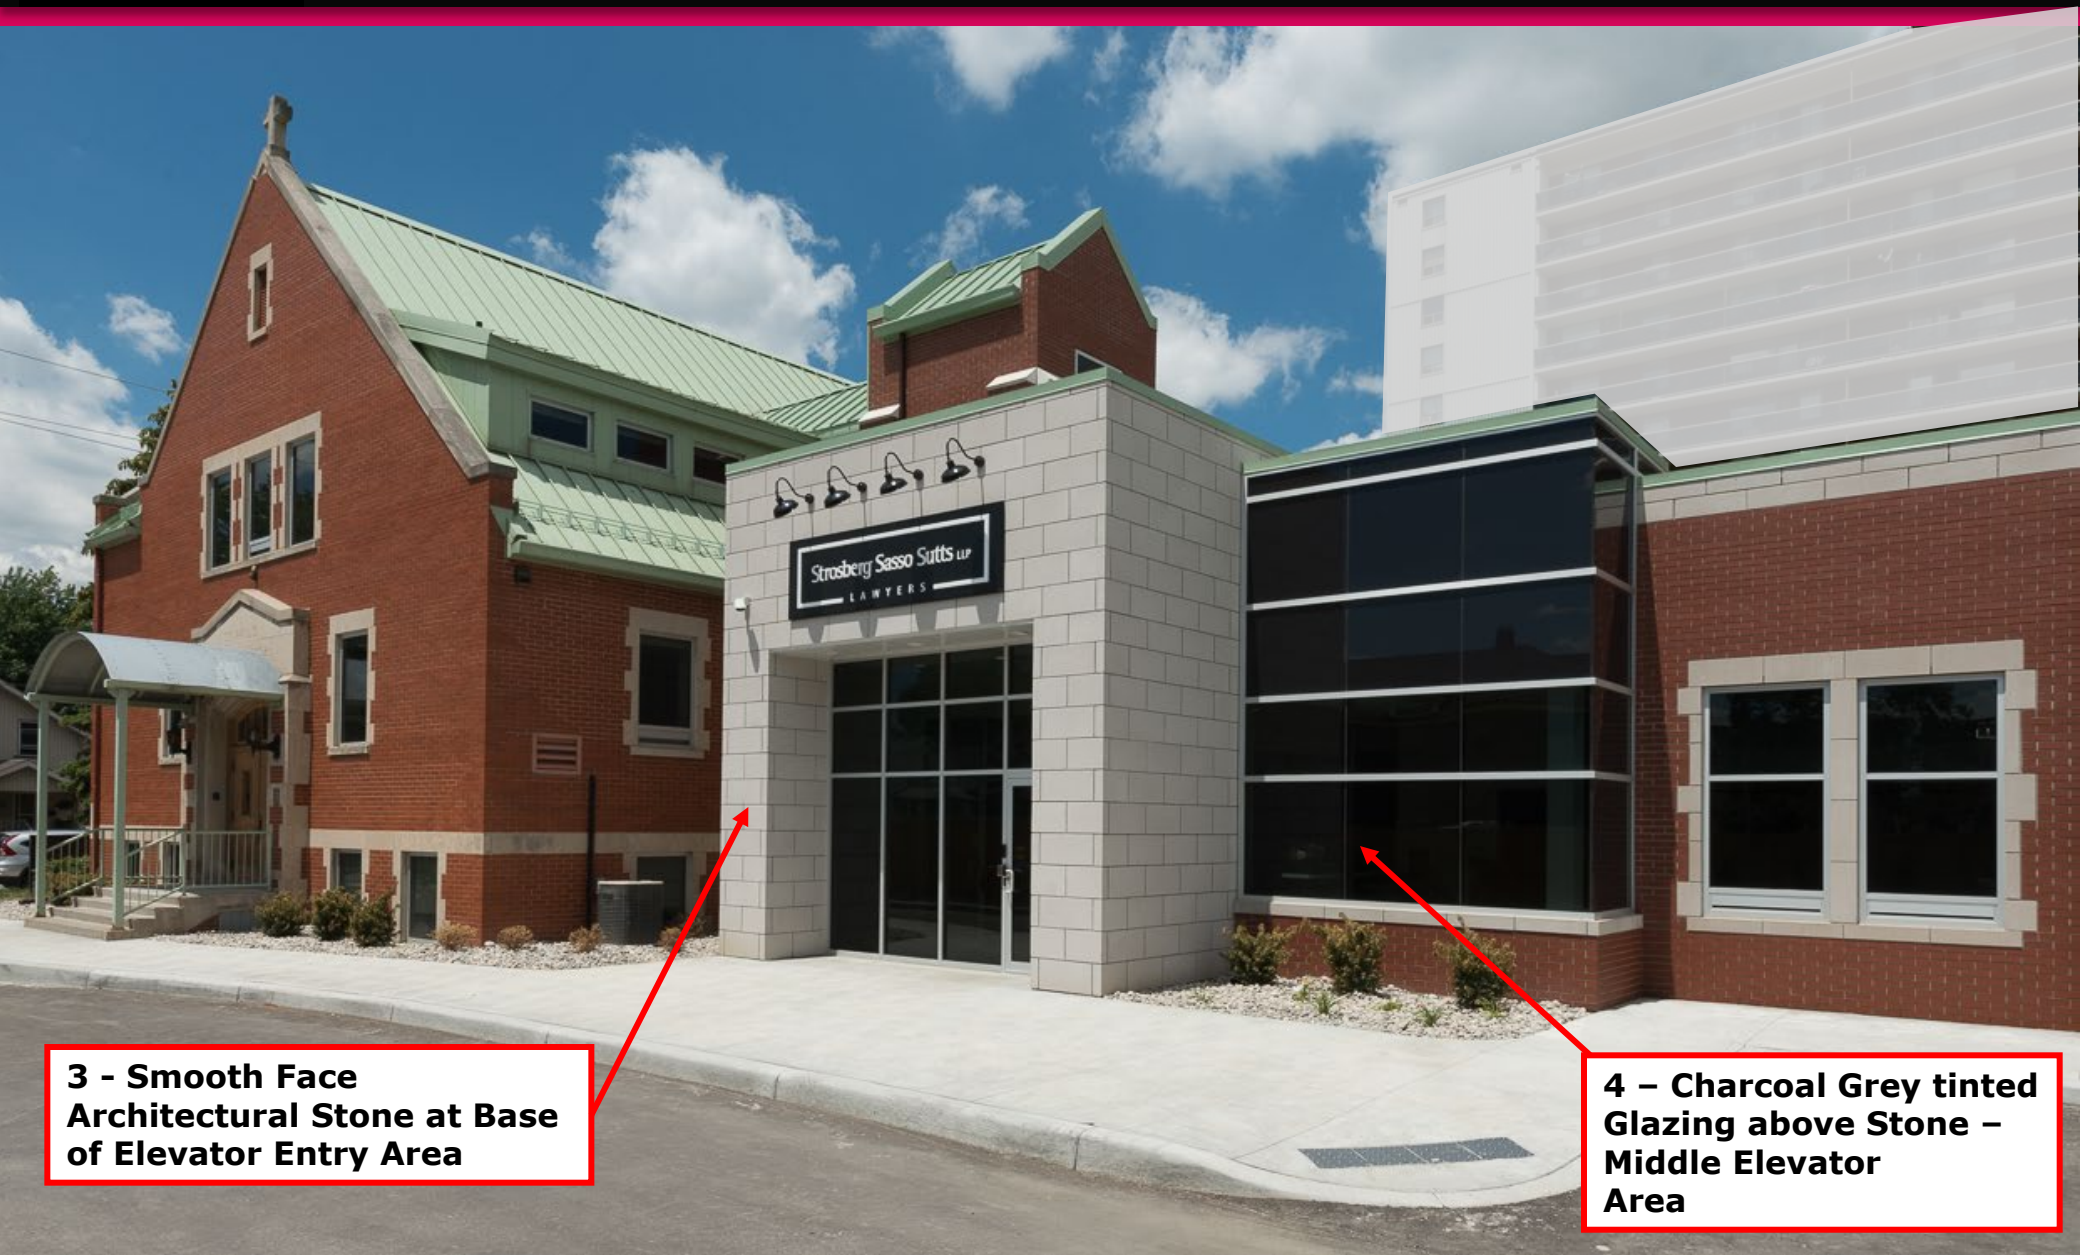
**3 - Smooth Face
Architectural Stone at Base
of Elevator Entry Area**

**4 - Charcoal Grey tinted
Glazing above Stone –
Middle Elevator
Area**

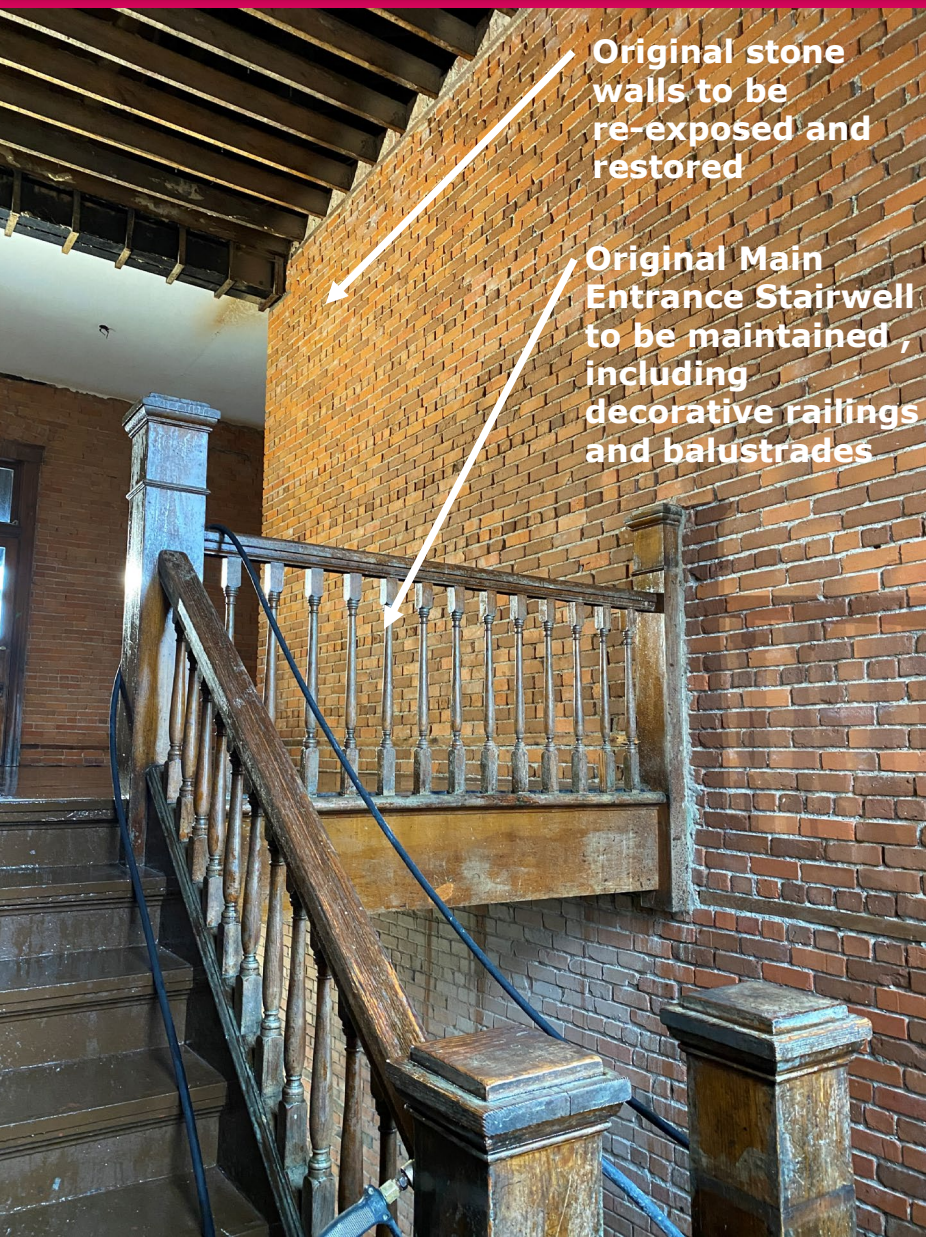
Original stone
walls to be
re-exposed and
restored

Original Main
Entrance Stairwell
to be maintained,
including
decorative railings
and balustrades

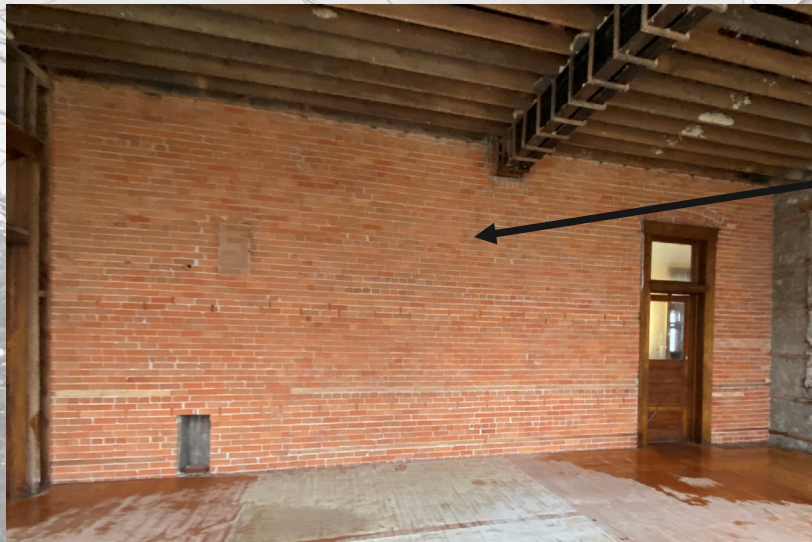
Original masonry walls are re-exposed and restored.

Original masonry arches and doorway mouldings are being maintained and/or restored

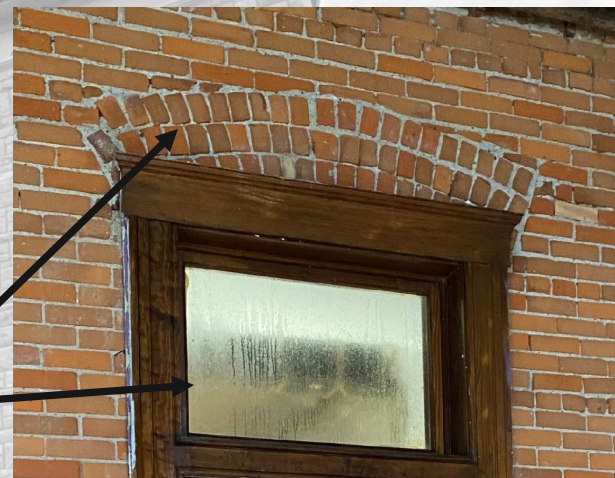
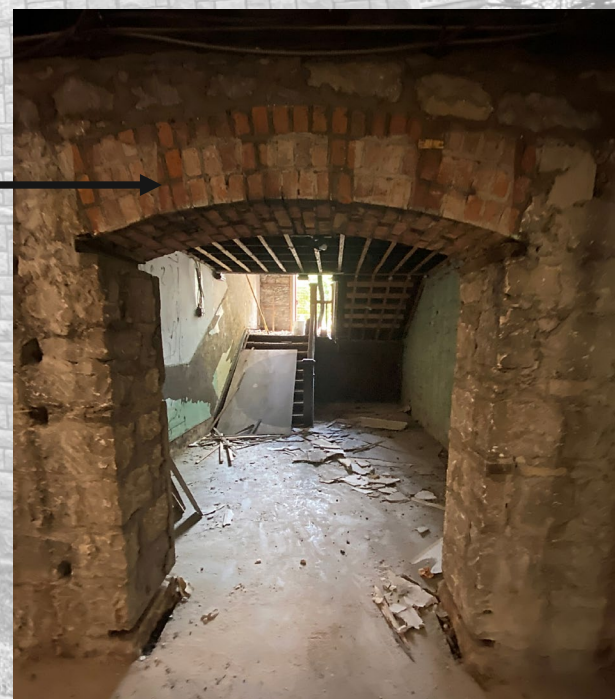
Original stone walls and masonry arches are being uncovered and restored

Original masonry walls are re-exposed and restored.

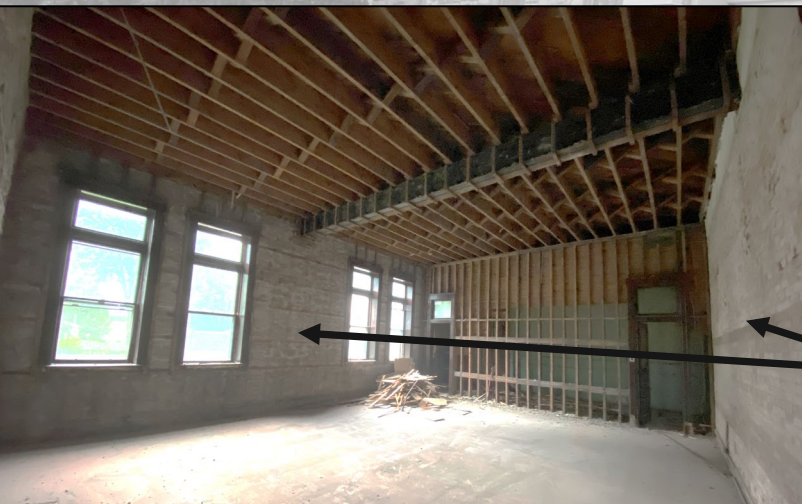
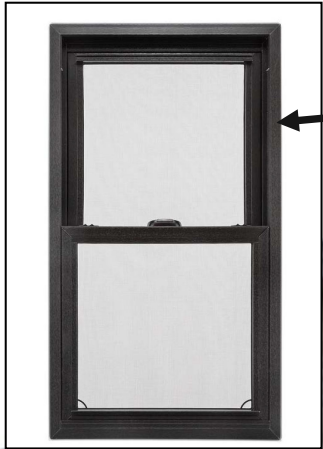
**Black Vinyl
(Exterior & Interior)
Modernized Windows,
with combination of
Double-Hung
(1-over-1 sashes)
and fixed units with
clear glazing to
replicate original
windows as best as
possible**

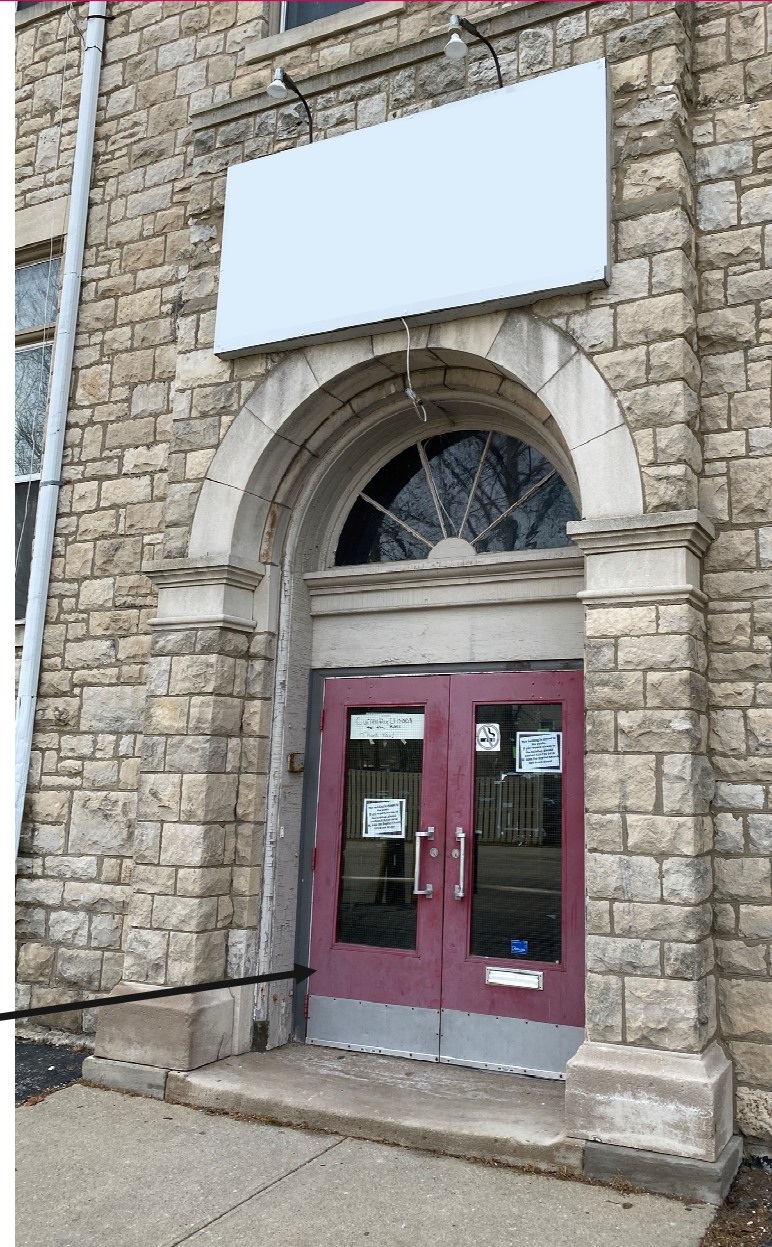
**Exterior Entry Doors
to be modernized
with aesthetics to
compliment the
Building Architecture**
