December 9, 2024

Project No. 25029

**RE: Amherstburg Town Centre  
South Elevation Facade**

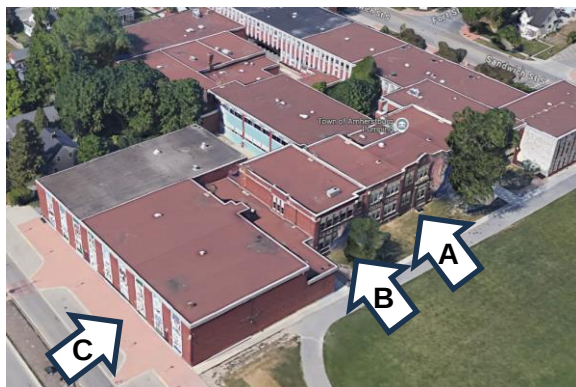
The purpose of the visit was to review the historic façade central to the South Elevation of the General Amherst High School (marked with an "A" on Figure 1), in order to provide options and recommendations with respect to its conservation and incorporation into a proposed new development on the site (see Figure 2). This façade was constructed ca. 1922 as part of the initial school building of what ultimately became a much larger complex. The building is not designated under Part IV of the Ontario Heritage Act.

An addition was constructed abutting the west side of the original school building ca. 1950 and is marked with a "B" on Figure 1. This addition was constructed to mimic the style and materials of the original façade, but it is understood that its retention is not being contemplated as part of the redevelopment, and it was therefore not reviewed in any detail.

A set of mural panels painted on more contemporary parts of the building along the West Elevation were also reviewed (marked with a "C" on Figure 1). It is understood that six of the panels are on the former gymnasium building, which is planned to be retained (and is visible in Figure 2). However, three of the panels are on a separate building to the north which is planned to be demolished.

Fig. 1: Existing buildings, isometric view looking NE.

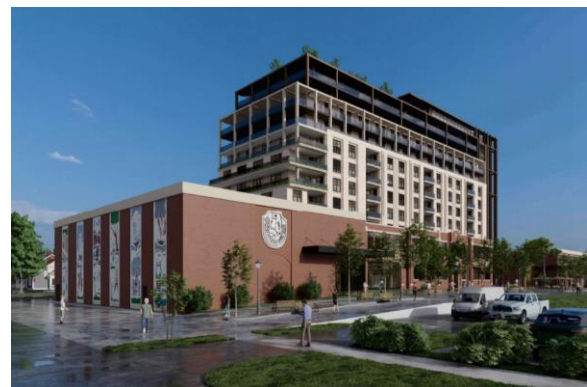
Fig. 2: Proposed development, also looking NE.

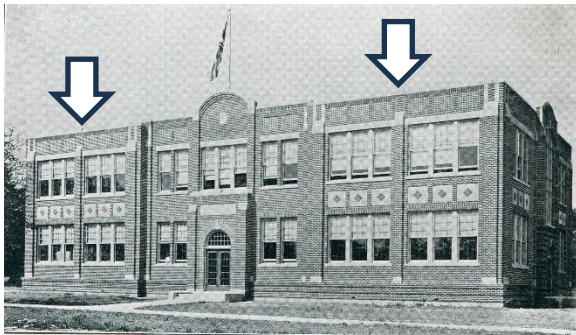
Fig. 3: Historic façade soon after original construction.

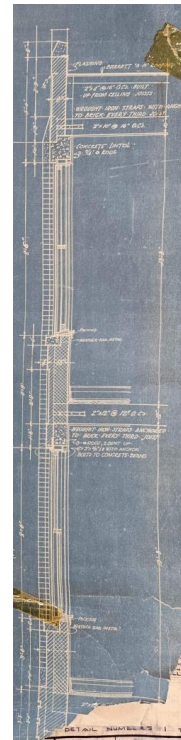
Fig 6: Section

The overall wall thickness at a typical location in the brick field is approximately 13", and the interior side backup for the outer brick consists of hollow terra cotta tile. This thickness includes approximately 4" for the exterior brick, ½" for a mortar collar joint, 8" for the terra cotta tile backup, and ½" for the interior plaster finish, applied to the tile. One interior investigatory opening made at the ground floor, though limited in size, was sufficient to confirm the presence of a plaster finish, the terra cotta tile, and the 8" thickness of the tile. See Figure 6 for a section at a typical wall elevation, from the 1921 drawings. Note that this drawing also shows the above-noted perpendicular joists and concrete lintel beams.

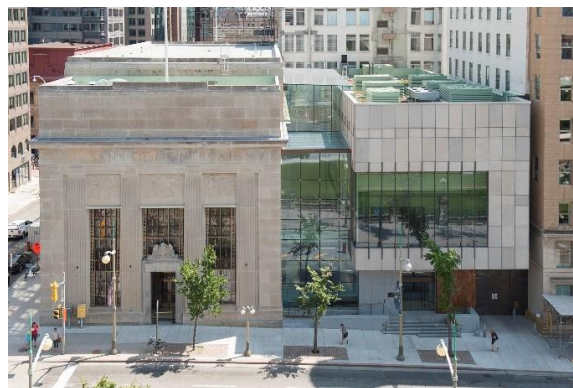
It is understood that a glass enclosure proud of the façade is being contemplated as part of either option. Glass interfacing with heritage masonry does tend to showcase the heritage fabric, and its lightness and transparency can give a certain deference to solid masonry as the primary feature of a space. Having a former exterior wall in a new interior space can also add a lot of interest and appeal. An example that the undersigned worked on extensively, and which won a CAHP award of excellence for adaptive re-use is the Sir John A. MacDonald building at 144 Wellington St. in Ottawa, ON (see Figure 21).

Fig. 21: Glass façade and atrium at SJAM Bldg.
