Facility Condition Assessment Report

Town of Amherstburg

Town Hall  
&  
Fire Station 1

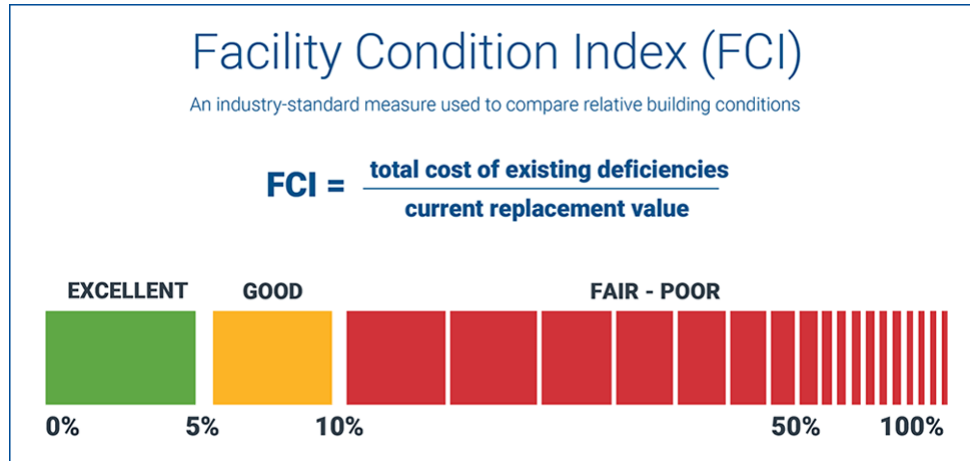
The FCI is an industry-standard key performance indicator (KPI) that can objectively quantify the current condition (i.e., physical health) or compare an individual building to other buildings in your portfolio.

The FCI does not identify priority actions or risk levels associated with the building, nor a detailed list of all the required Actions. It is based on the financial needs of the building only and can help building owners and managers make benchmark comparisons on the relative condition of buildings, but it should be used with care. Using these projected renewal and replacement costs, a future FCI can be predicted and demonstrate the changing conditions of the building in its lifetime.

Renewal and repair costs are determined by the identified Repair or Replacement Action items. The building replacement cost represents the construction cost of the same size building, with the same function, following current Standards and Codes, exclusive of land or real estate market costs.
